FIELD OBSERVATION #23

Project: Washington Fire Station
Washington, Iowa

Date: October 16, 2019
Time: 1:00 p.m.

Project:	City of Washington Fire Station Phase 2	Project Number:	17-113	Date:	October 28, 2019
To:	Design Alliance				
From:	Tyler J. Luttenegger, P.E.	Observation Date:	October 17, 2019

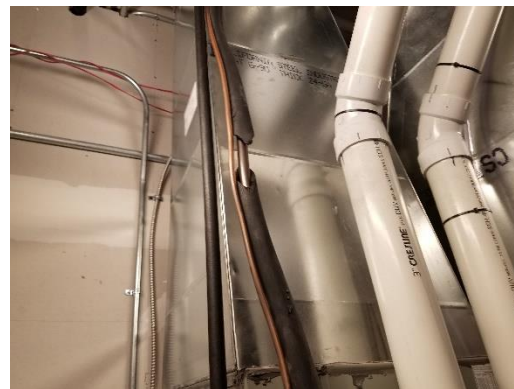
Mech / Elec #106:

- Hot water recirculation pump HCP-1 is not wired.
- Repair section of missing insulation on refrigerant piping serving furnace F-2. See photo on right.

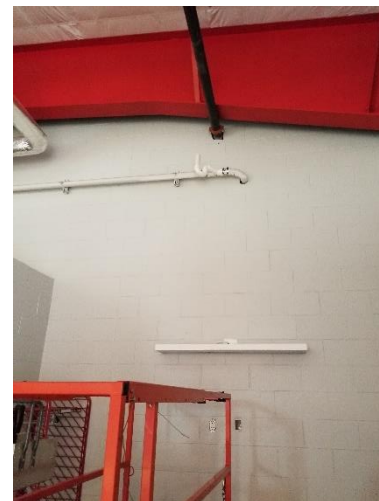
Gear Room #117:

- Contractor to verify what the intent for this section of pipe is. See photo on right.

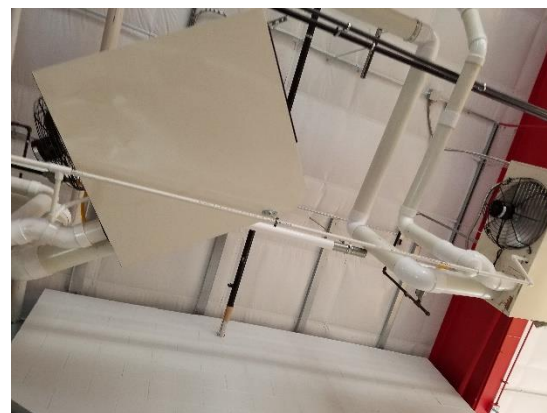
Apparatus Bay #120:

- Owner furnished, contractor installed pressure washer hose missing.
- Condensate pipe serving unit heater near south wall needs to be supported properly from structure above. It is currently being supported by the adjacent unit heater. See photo Unit Heater Condensate Drain.
- Stainless steel drain pan and associated condensate drain piping serving mini-split condensing unit MSCU-1 is missing.
